**RE: Prior Reclamation Status, Anne Lee, Sandstone and John Bill Mines, McKinley County, New Mexico**

**PRIOR RECLAMATION INSPECTION REPORT  
AND  
RECOMMENDATION FOR RELEASE OR PERMIT  
REQUIREMENT**

**United Nuclear Corporation - Anne Lee Mine**

**September 18, 1995**

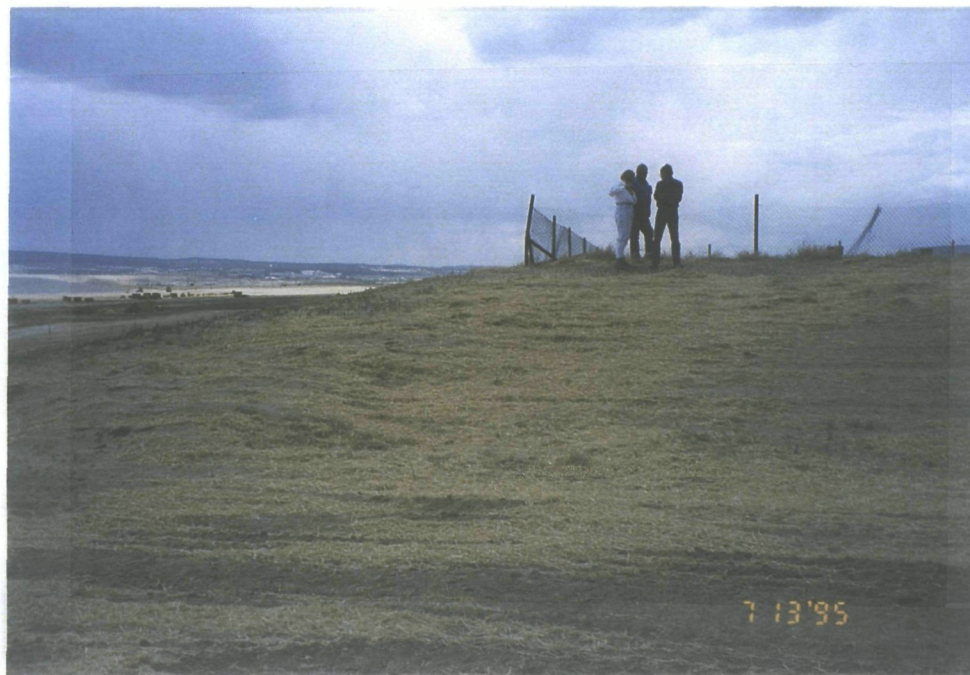
*Photo 2. Site Mound from south, 20 yards from site*

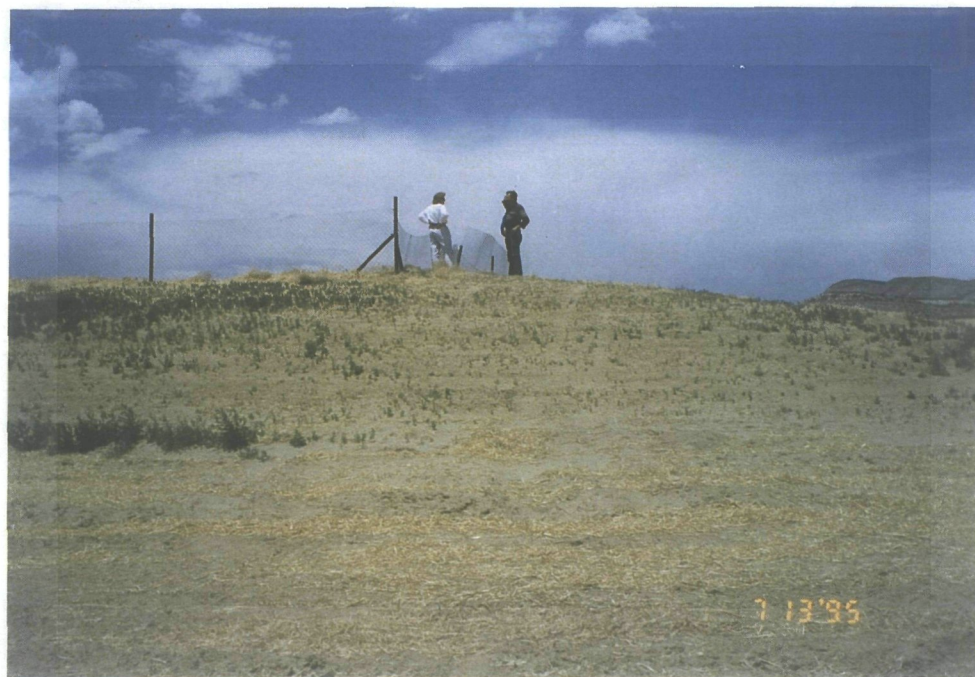
*Photo 1. Site Mound from east, 20 yards from site*

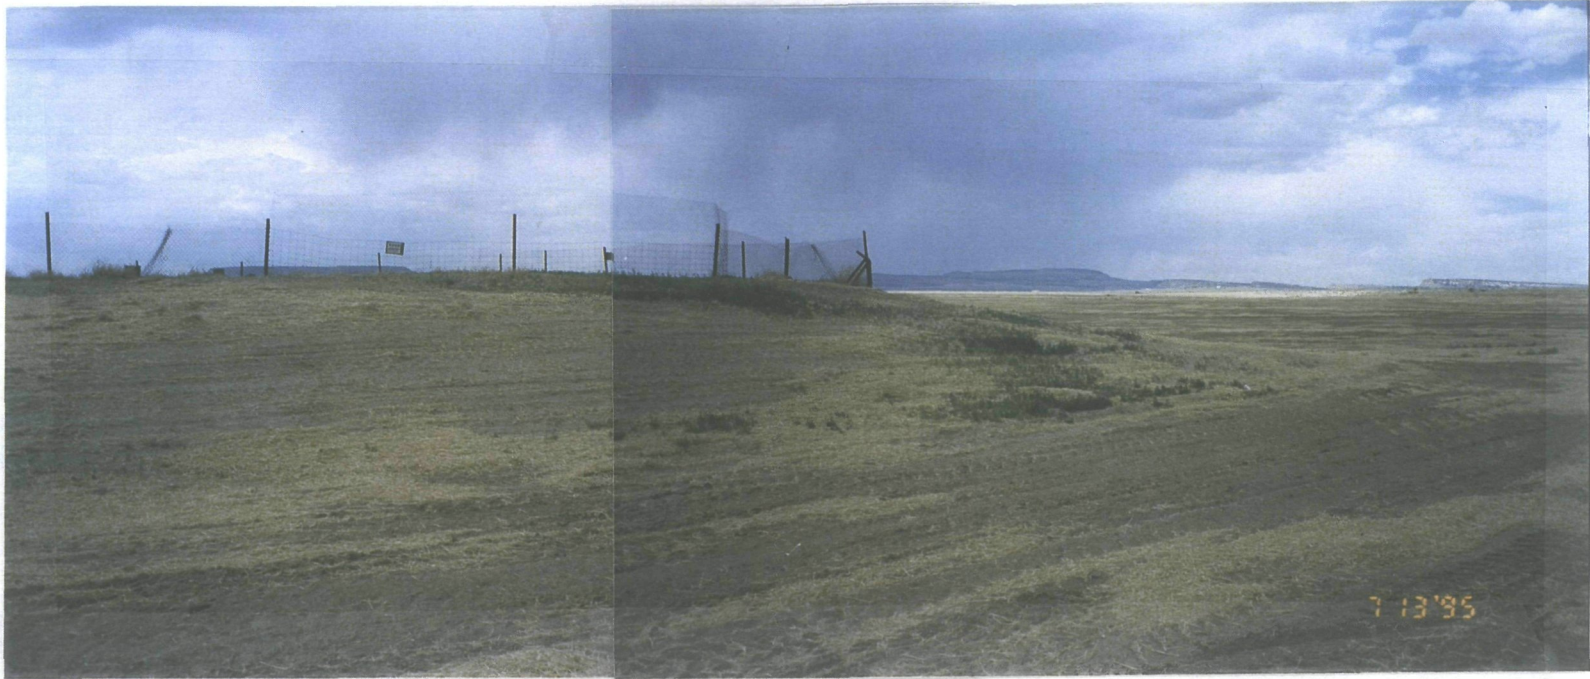
There were no erosion features. All out slopes were stable.

Figure 5&6. Side slope of site from east

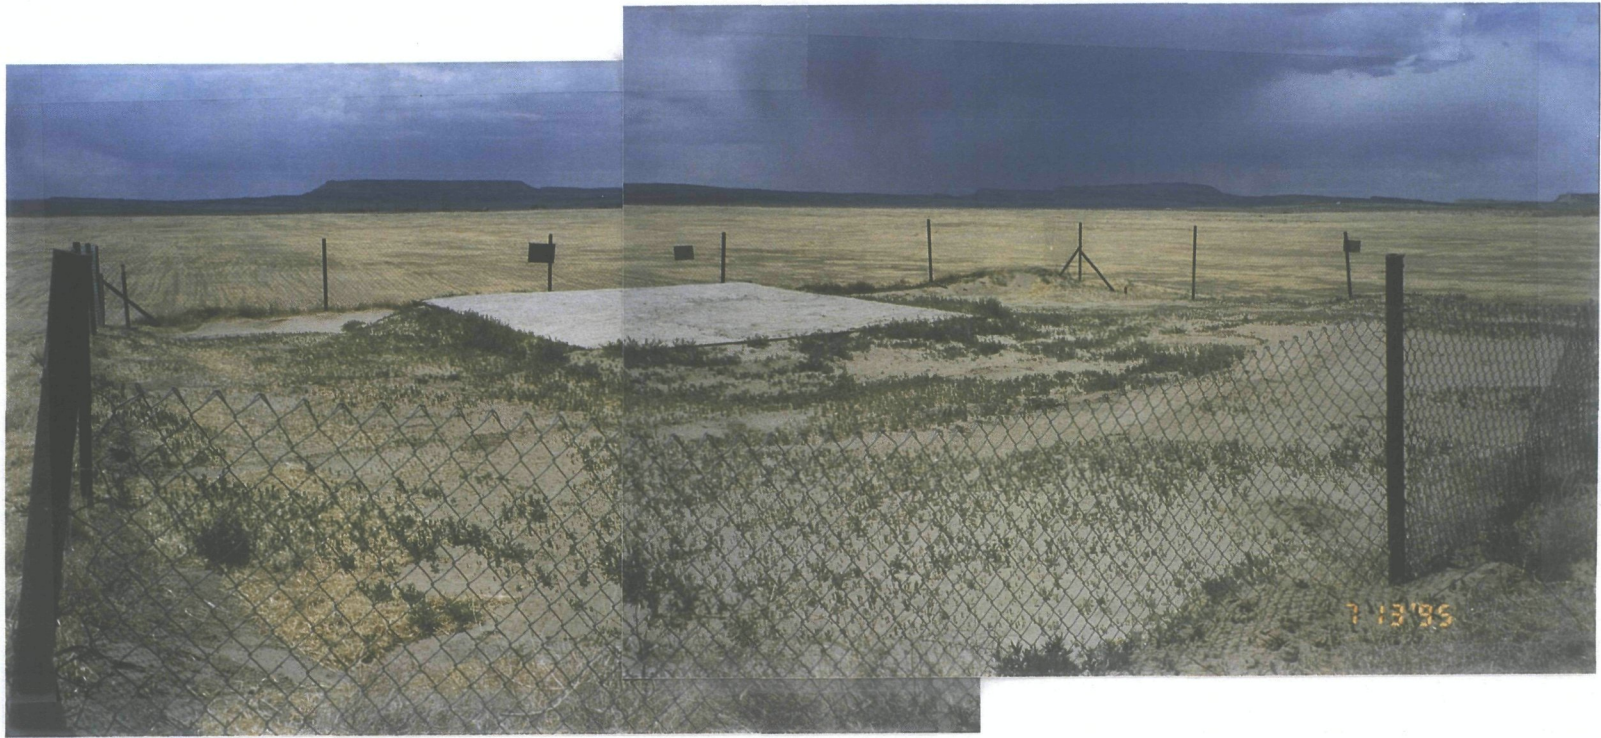
The mine shaft was backfilled with nontoxic mine waste material and capped with a concrete slab approximately 20 foot square and 4 feet thick. The concrete cap was not covered with soil.

*Photos 3&4. Top of site with concrete cap from southeast*

1. The concrete slab covering the shaft must be covered by a minimum of two feet of topsoil or suitable material.
